PERFORMANCE OF LATEX MODIFIED AND  
LOW SLUMP CONCRETE OVERLAYS ON BRIDGE DECKS

Addendum Report to MCHRP 83-1

Survey Results of Structures After  
9 to 13 years of Service

Research Investigation 84-2

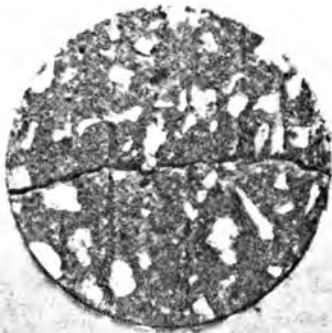
CORE NO. 2

Bridge No. A-1763  
Clay County

1.8" Latex Concrete  
Large Crack  
Depth 1.7"

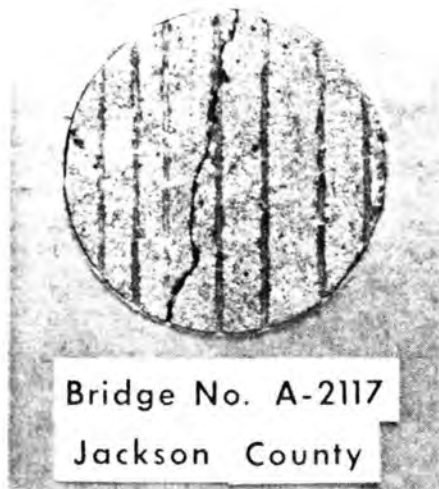
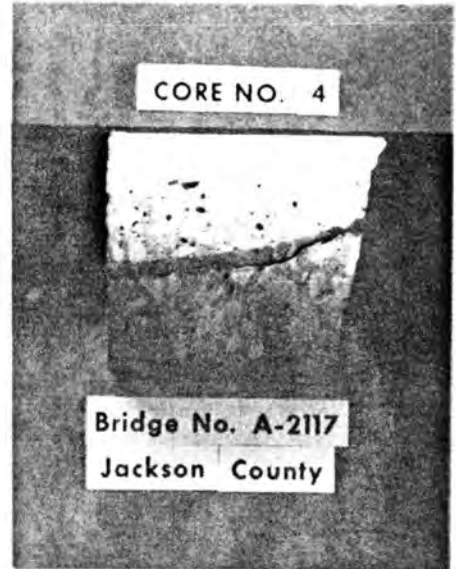
CORE NO. 4

2.7" Low Slump  
Medium Crack  
Depth 3.7"

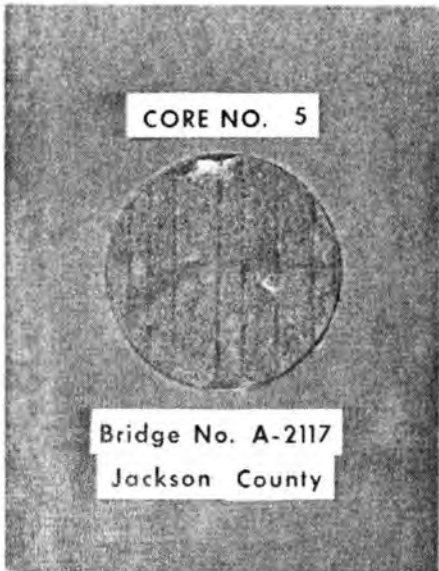
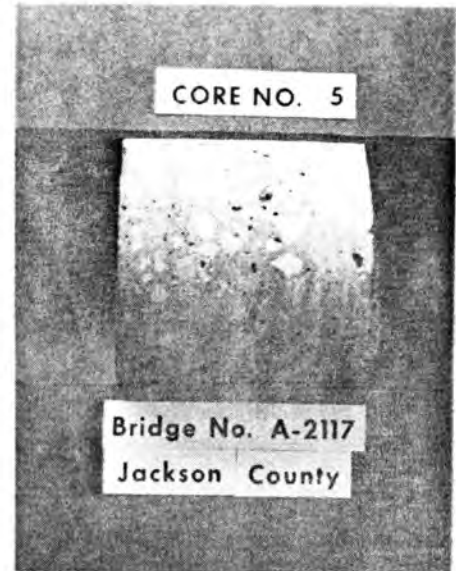
CORE NO. 5

2.7" Low Slump  
Fine Crack  
Depth 0.0"

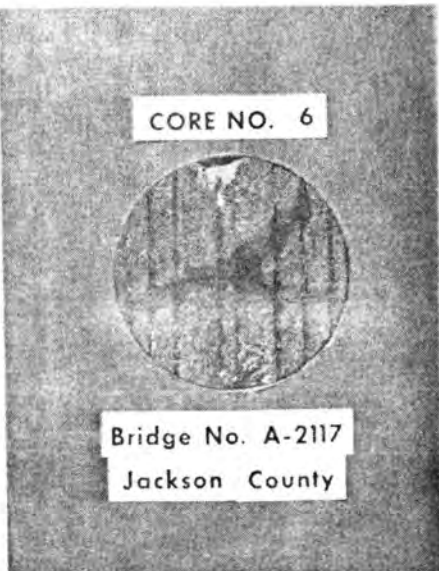
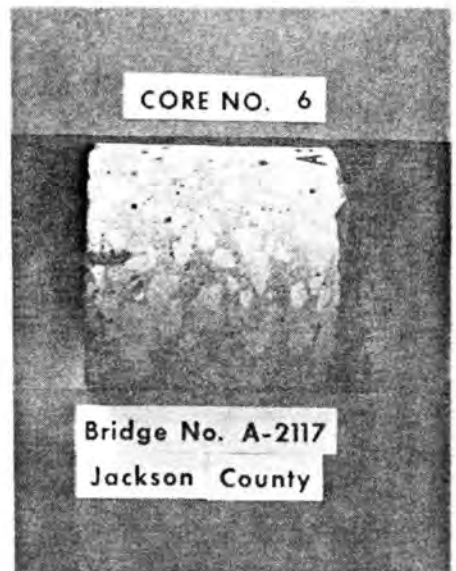
CORE NO. 6

2.9" Low Slump  
Fine Crack  
Depth 0.4"

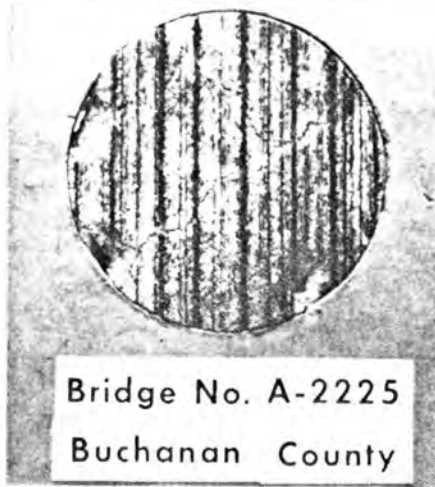
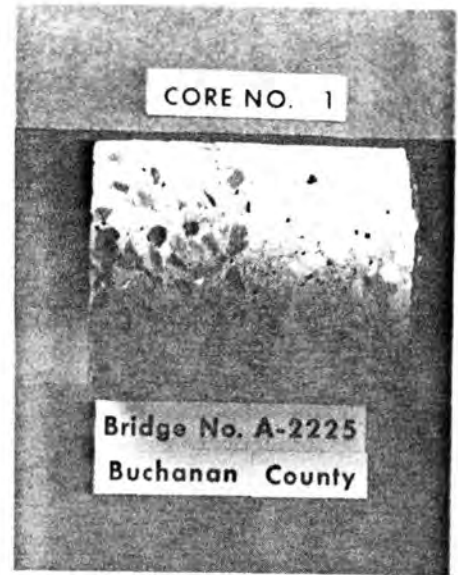
CORE NO. 1

2.4" Low Slump  
Fine Crack  
Depth 0.9"

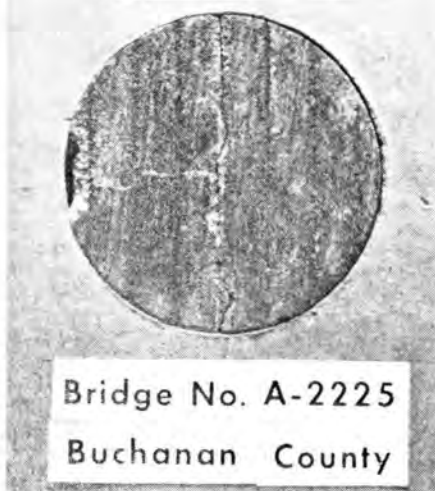
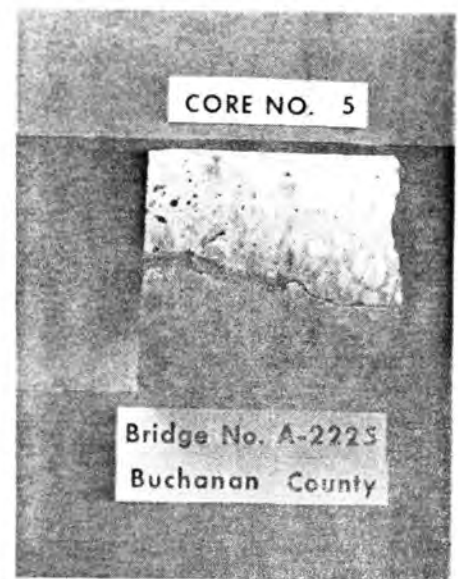
CORE NO. 5

2.2" Low Slump  
Fine Crack  
Depth 2.2"

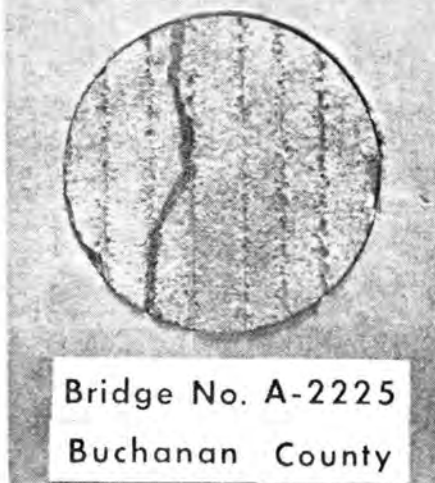
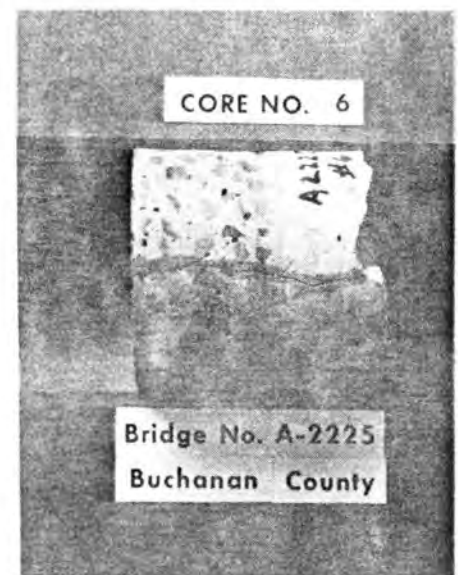
CORE NO. 6

2.1" Low Slump  
Fine Crack  
Depth 3.4"+

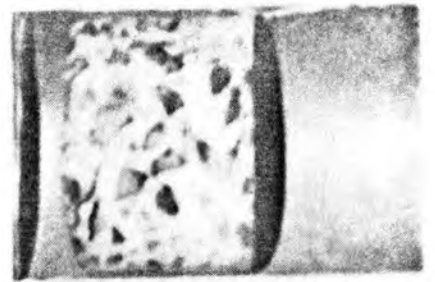
CORE NO 1

2.5" Low Slump  
Fine Crack  
Depth 0.3"

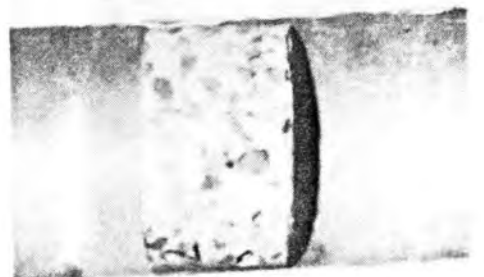
CORE NO 1

2.1" Low Slump  
Fine Crack  
Depth 0.5"

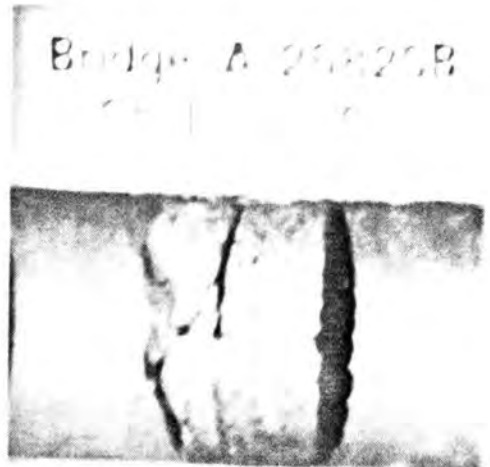
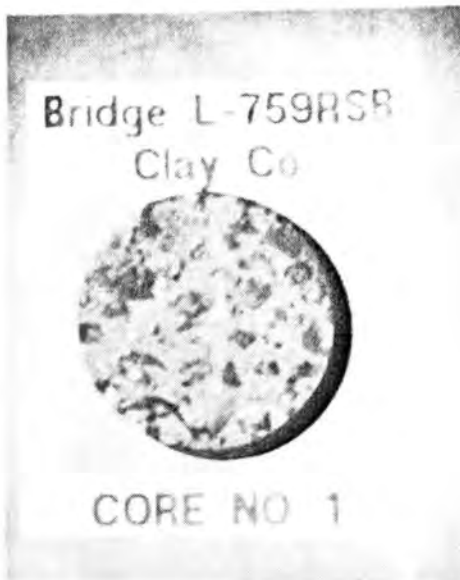
1.2" Latex Mortar  
Medium Crack  
Depth 2.4"

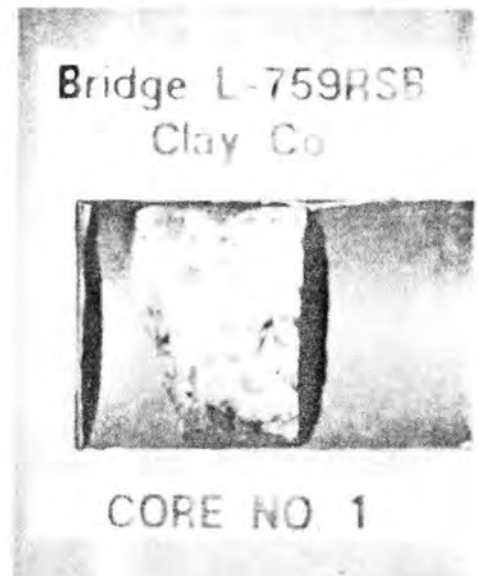
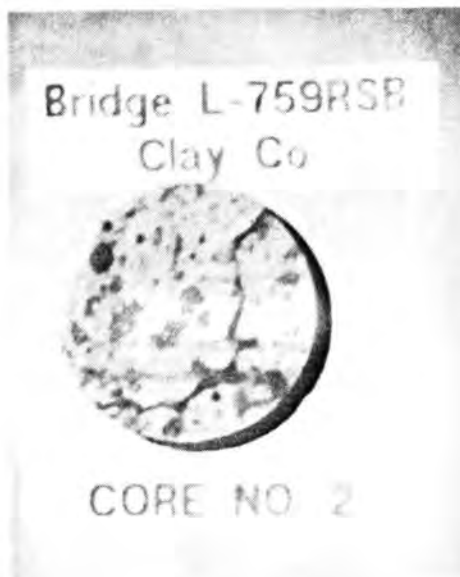
1.7" Latex Concrete  
Fine Crack  
Depth 0.4"

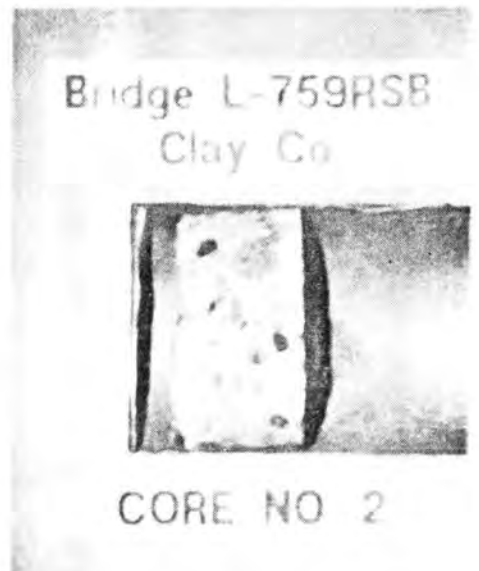
1.7" Latex Concrete  
Large Crack  
Depth 0.6"
